# SHANDONG DOORWIN CONSTRUCTION CO., LTD. FLORIDA BUILDING CODE TEST REPORT

TAS 201, TAS 202 AND TAS 203 TESTING ON 95S THERMAL BREAK ALUMINUM HINGED DOORS.

250815008SHF-001

**Series/Model:** DW95S

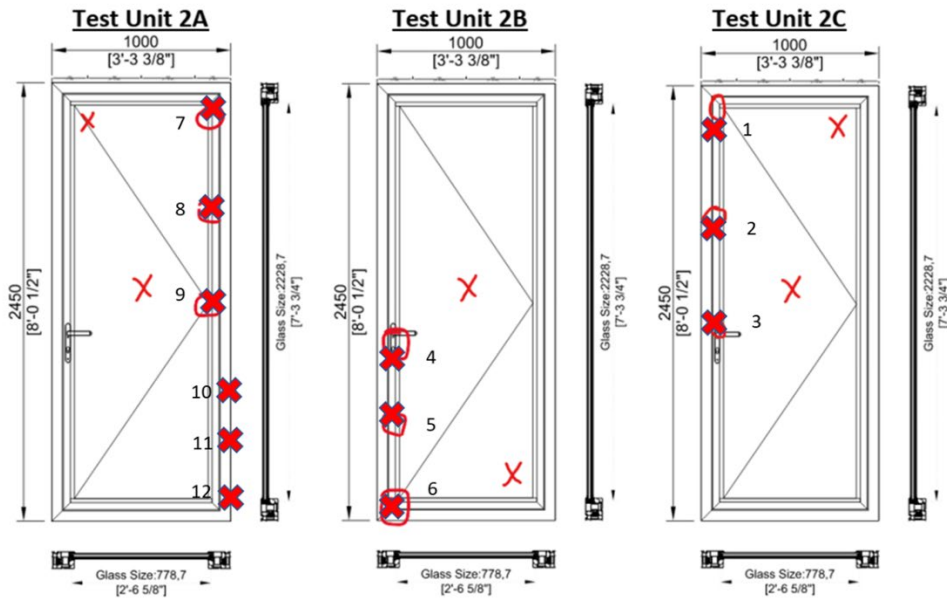
Sketch No. 1

TAS 202 Indicator Locations of specimen #01, #02 and #03

**Note 5:** See Sketch No.1 for indicator locations. Deflection/permanent set reported is the overall deflection between three points (longest unsupported span) which accounts for support movement.

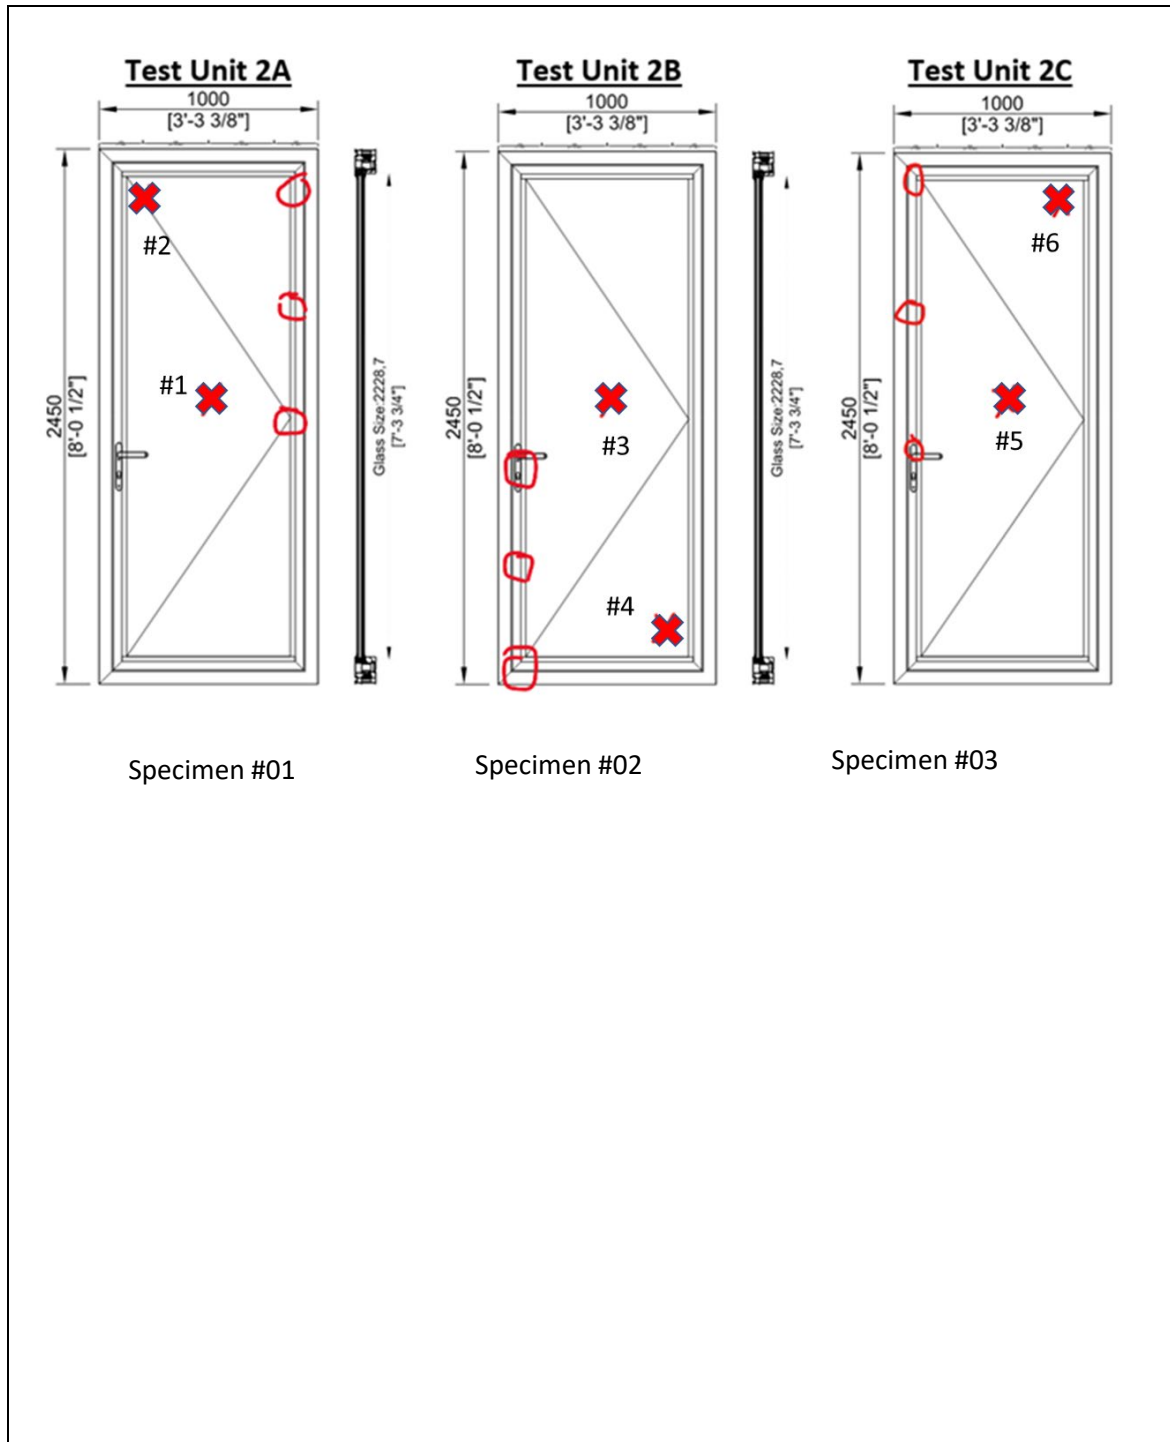
TAS 201 Impact Locations of specimen #01, #02 and #03

**Note 6:** See Sketch No.2 for impact locations.

The large missiles impacted each intended target. Each impact location was carefully inspected. No signs of penetration, rupture, or opening after the large missile impact test were observed; as such, each test specimen satisfies the large missile requirements of TAS 201. Upon completion of testing, specimens tested for TAS 201-94 met the requirements of Section 1626 of the Florida Building Code, Building.

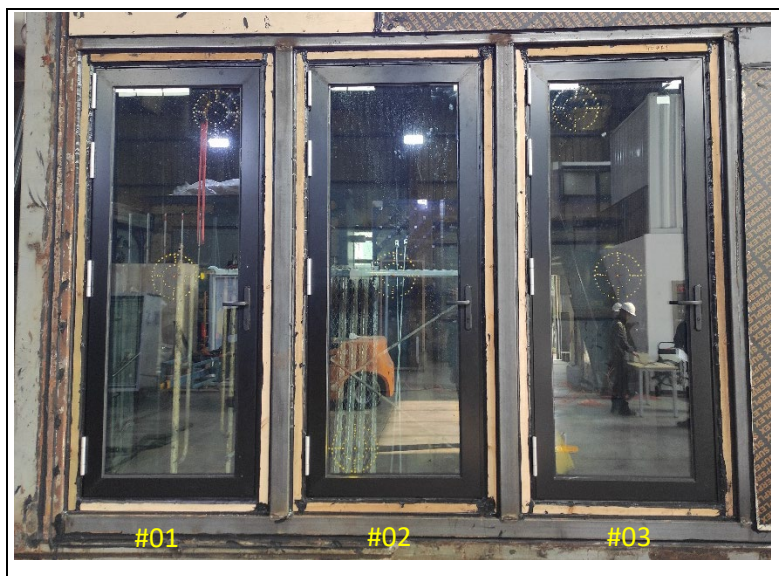
**Photo No. 1**  
**Specimens #01, #02 and #03 before impact test (Testing on December 1, 2025)**

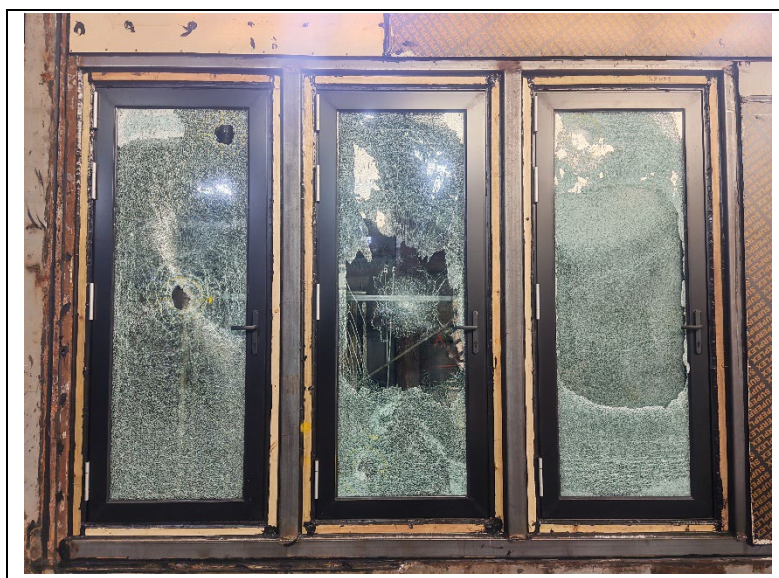
**Photo No. 2**  
**Specimens #01, #02 and #03 after impact test (Testing on December 1, 2025)**

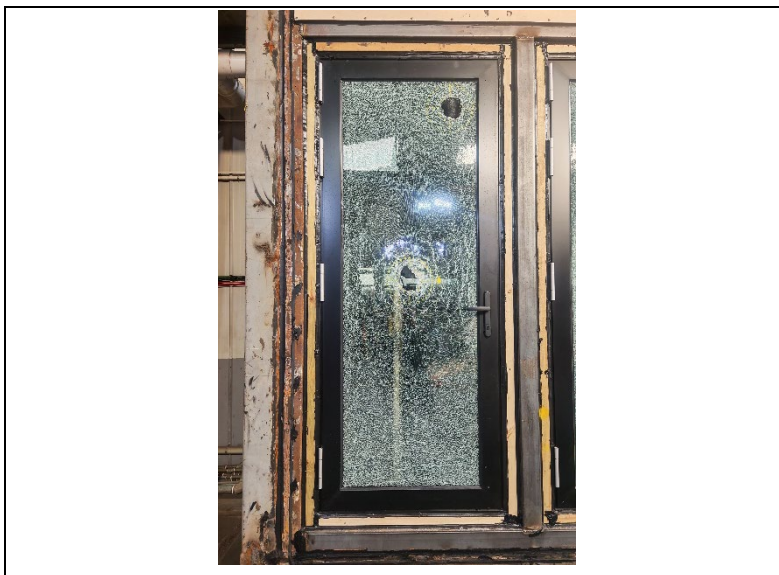
**Photo No.3**

**Specimen #01 after impact test (Testing on December 1, 2025)**

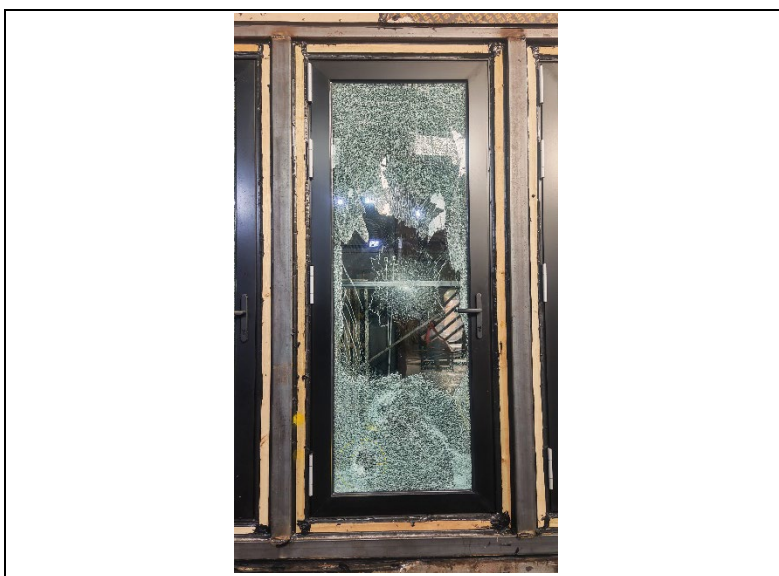
**Photo No.4**

**Specimen #02 after impact test (Testing on December 1, 2025)**

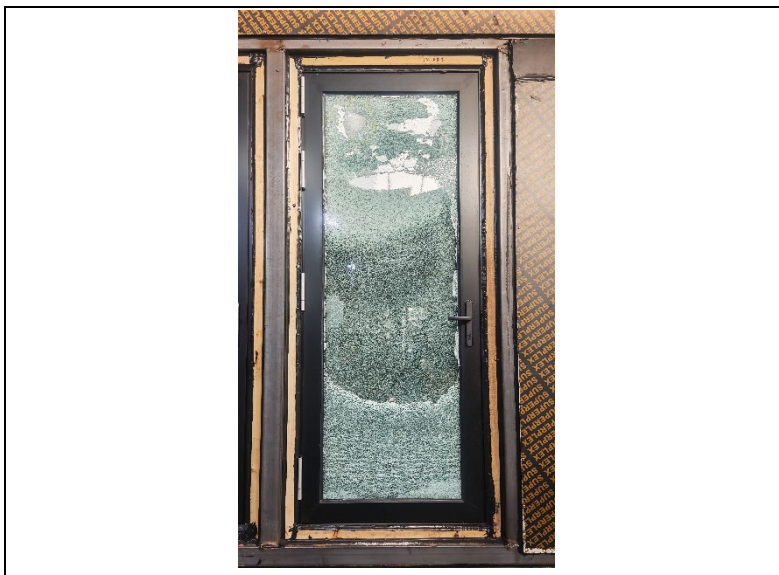
**Photo No.5**

**Specimen #03 after impact test (Testing on December 1, 2025)**

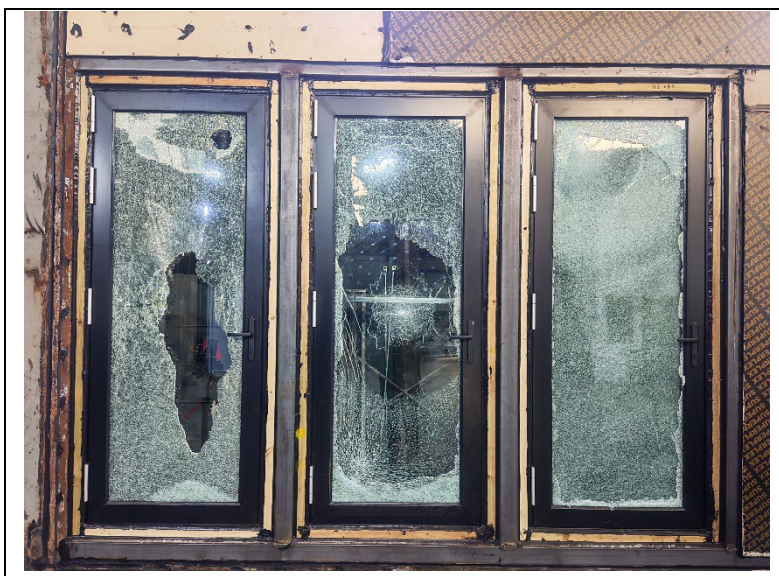
**Photo No.6**

**Specimen #01, #02 and #03 after cyclic test (Testing on December 2, 2025)**

No signs of failure were observed in any area of the test specimens during the cyclic load test; as such, the test specimens satisfy the cyclic load requirements of TAS 203. Upon completion of testing, specimens tested for TAS 203-94 met the requirements of Section 1626 of the Florida Building Code, Building.

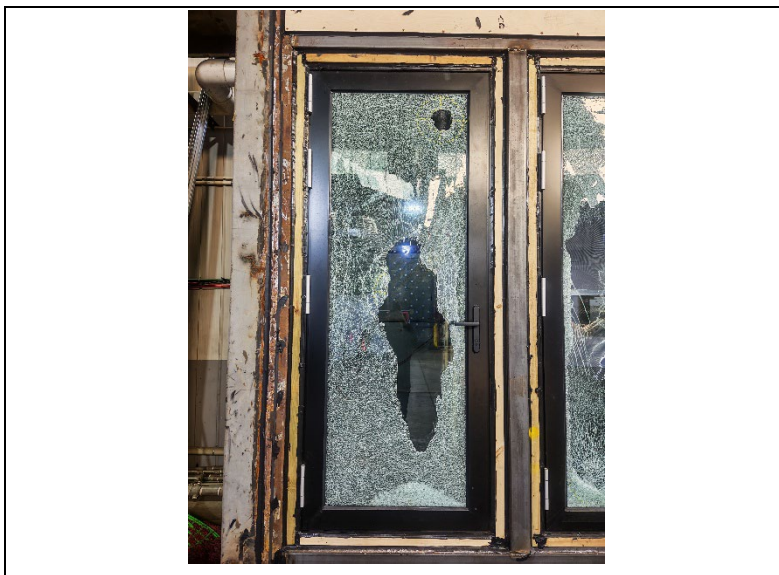
**Photo No.7**

**Specimen #01 after cyclic test (Testing on December 2, 2025)**

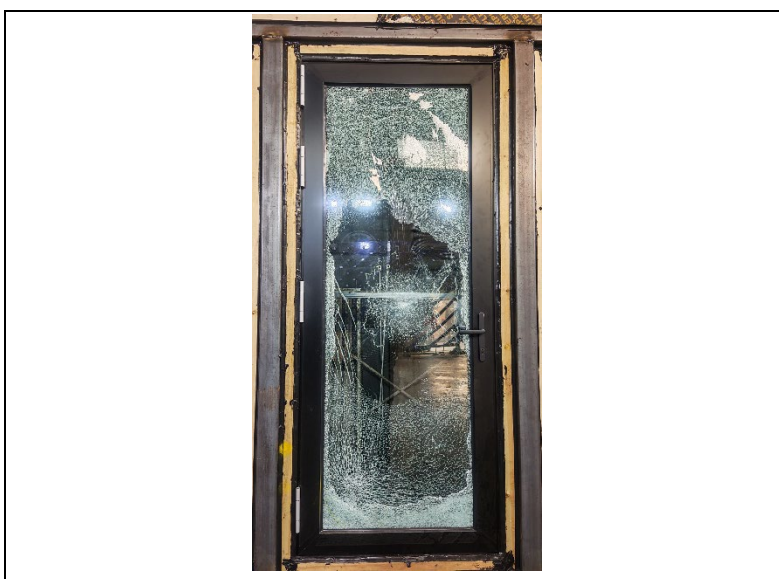
**Photo No.8**

**Specimen #02 after cyclic test (Testing on December 2, 2025)**

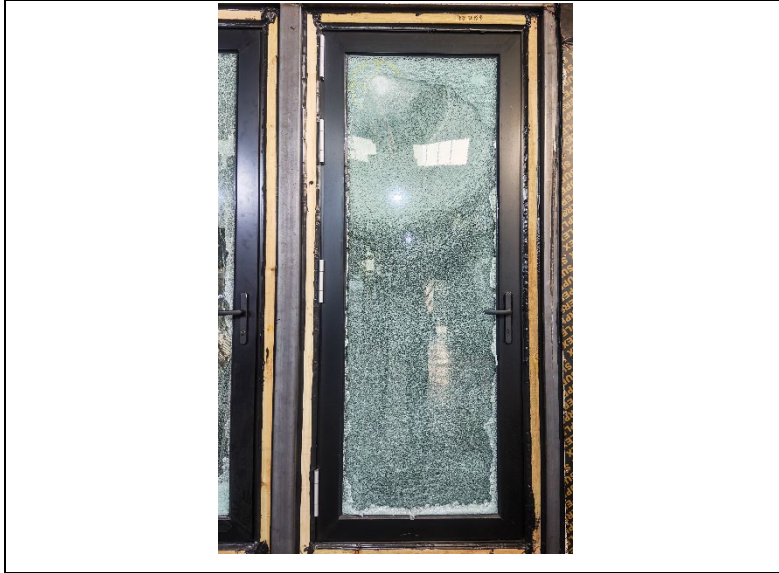
**Photo No.9**

**Specimen #03 after cyclic test (Testing on December 2, 2025)**

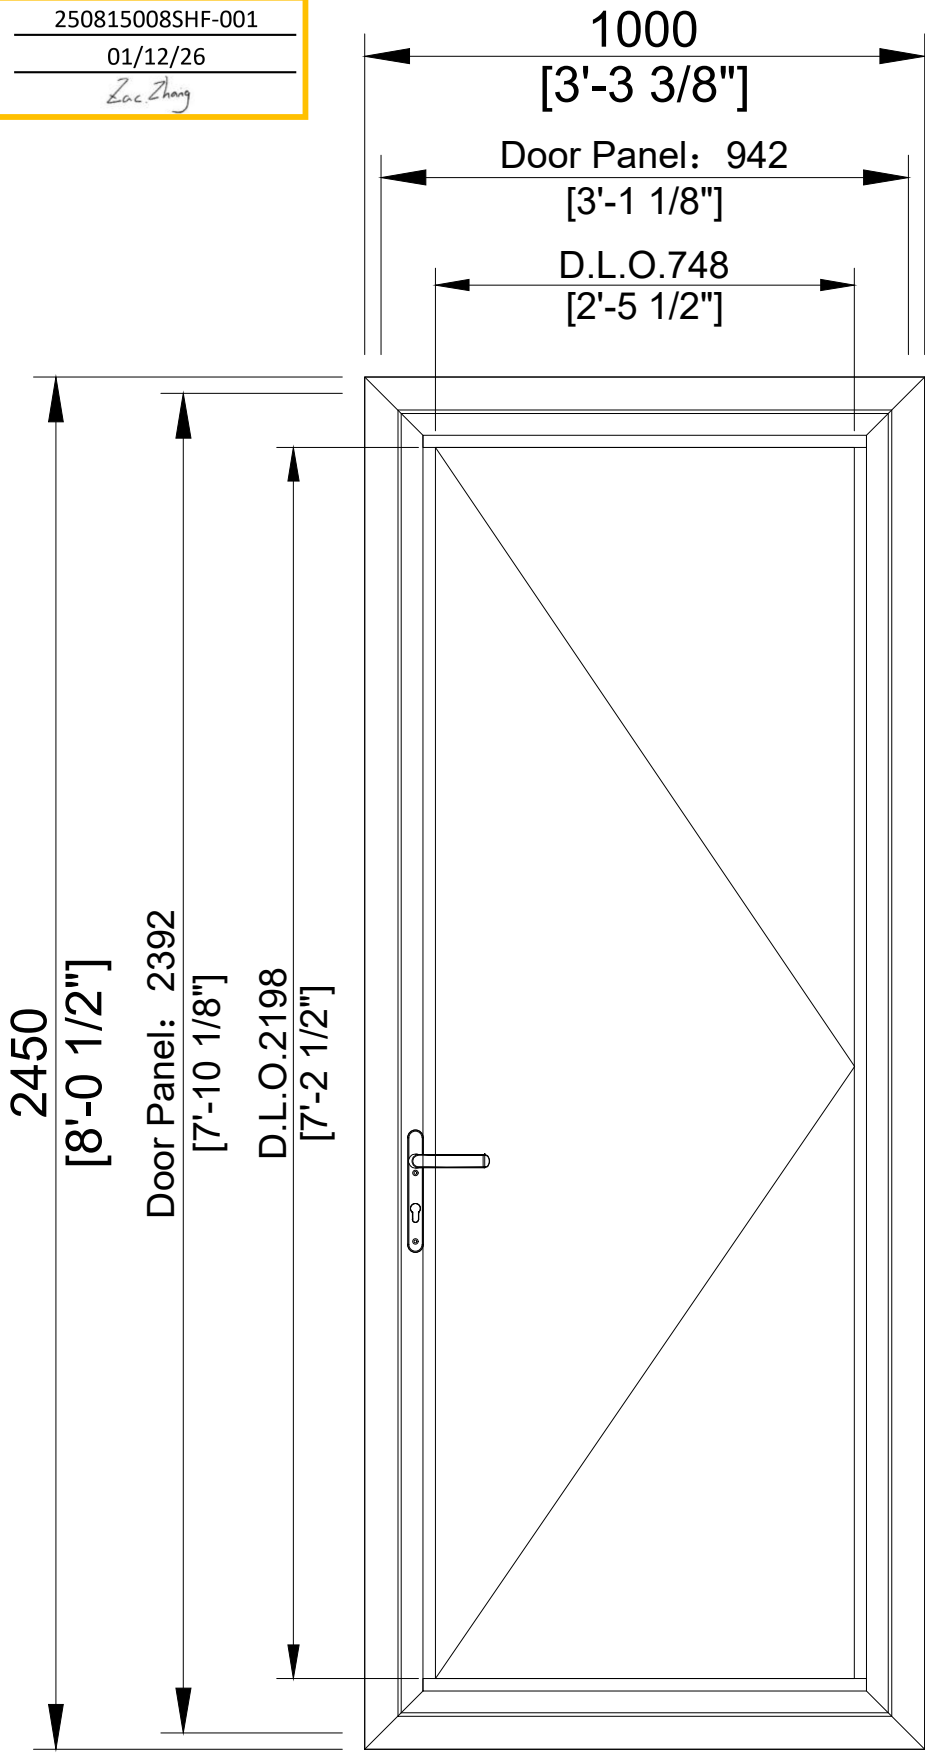
Elevation of door  
Interior View

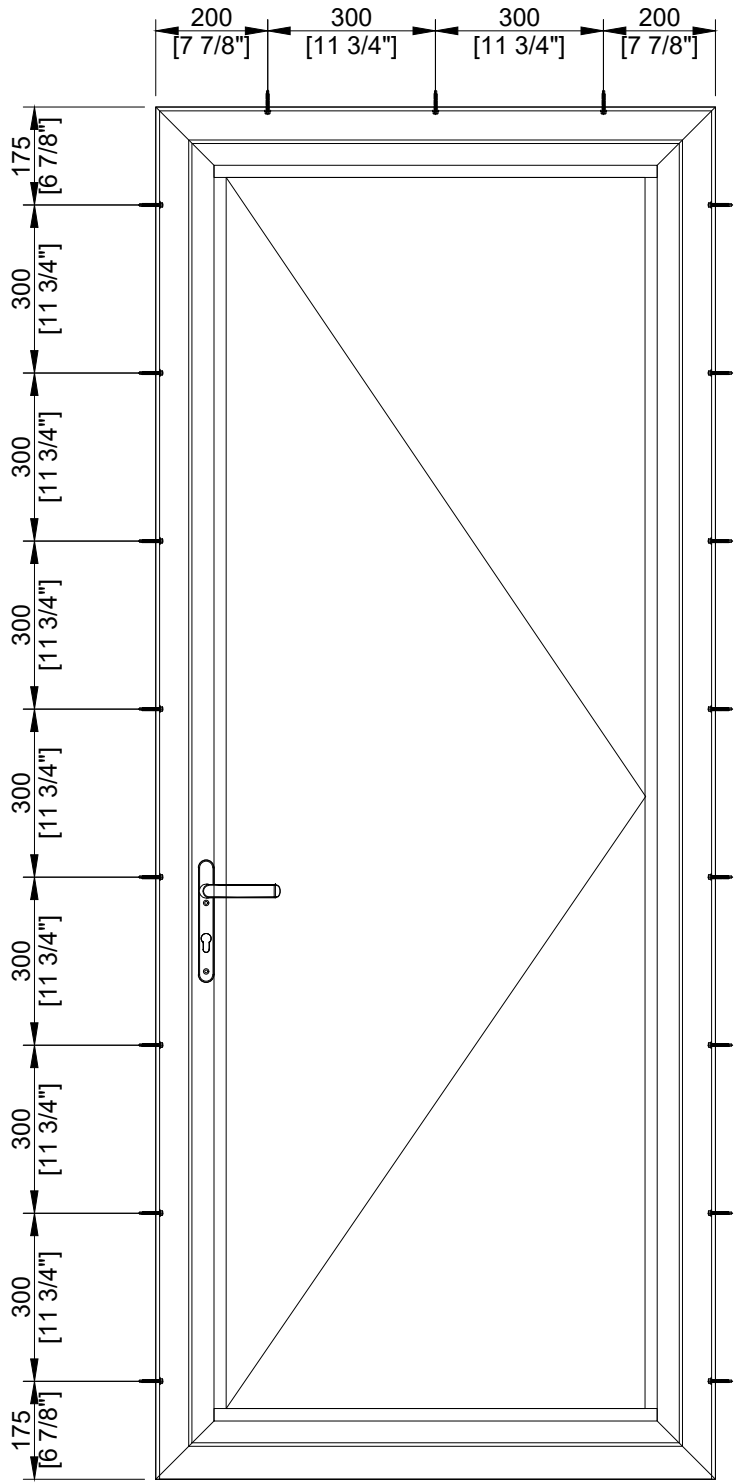
Position of the Anchor Screw

| LOCATION | ANCHOR DESCRIPTION | ANCHOR LOCATION |
|---|---|---|
| Head | 3/16" DIA. x 1-1/2" Length Anchor Screw. | Anchor 7-7/8" from ends and 11-3/4" on center. |
| jambs | 3/16" DIA. x 1-1/2" Length Anchor Screw. | Anchor 6-7/8" from ends and 11-3/4" on center. |

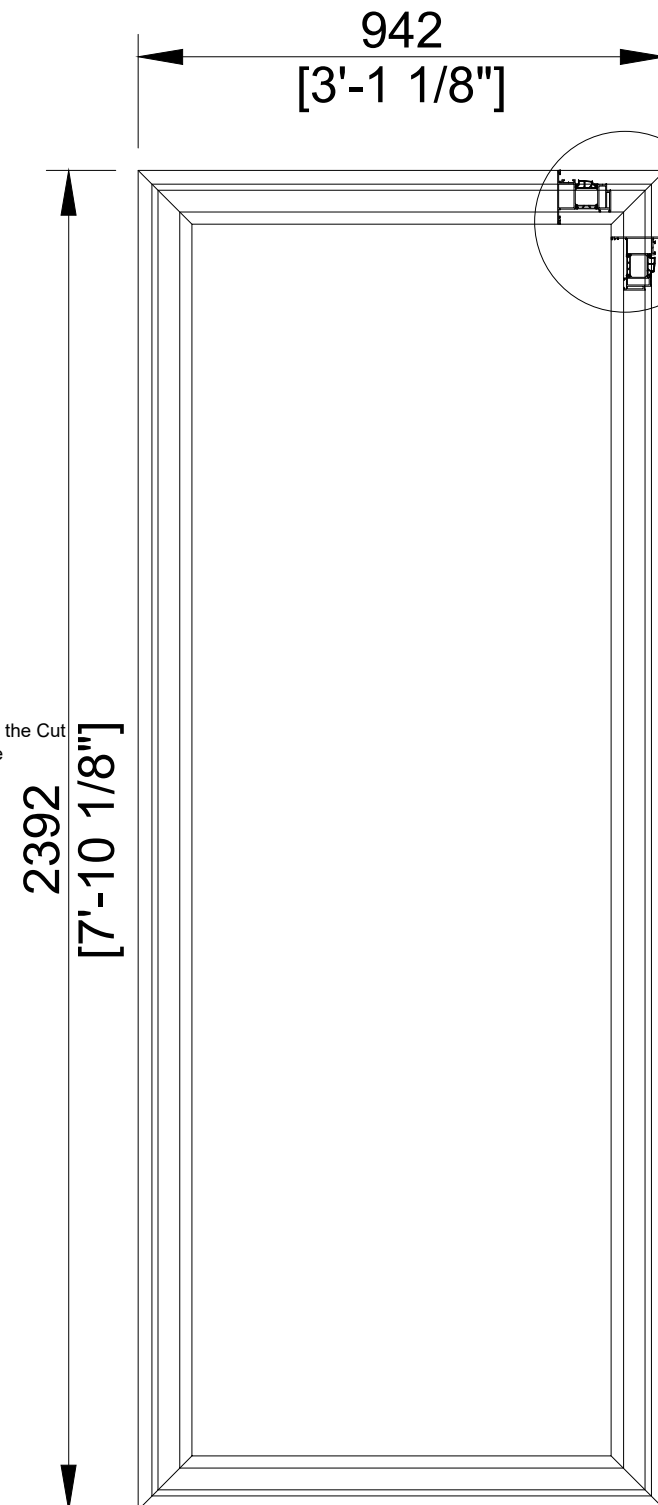
Door Panel  
Interior View

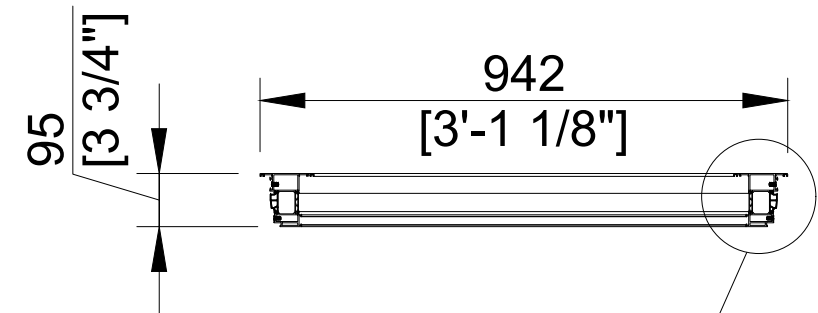
Description: The four  
corners of the window  
frame are connected  
in the same way

**NO.P35**  
**MODEL:** 1/4\*\*1/2"  
**DESCRIPTION:** Solid Screw  
**MATERIAL:** Stainless Steel

| FRAME MEMBER | PART # | MATERIAL | DESCRIPTION |
|---|---|---|---|
| All Corners | Aluminum<br>corner<br>connector | Jambs were 45° angle cut, connect the frame with corner key<br>HLG26, fixed with 1/4"x1/2" corner key screws, sealant with<br>P39. | |

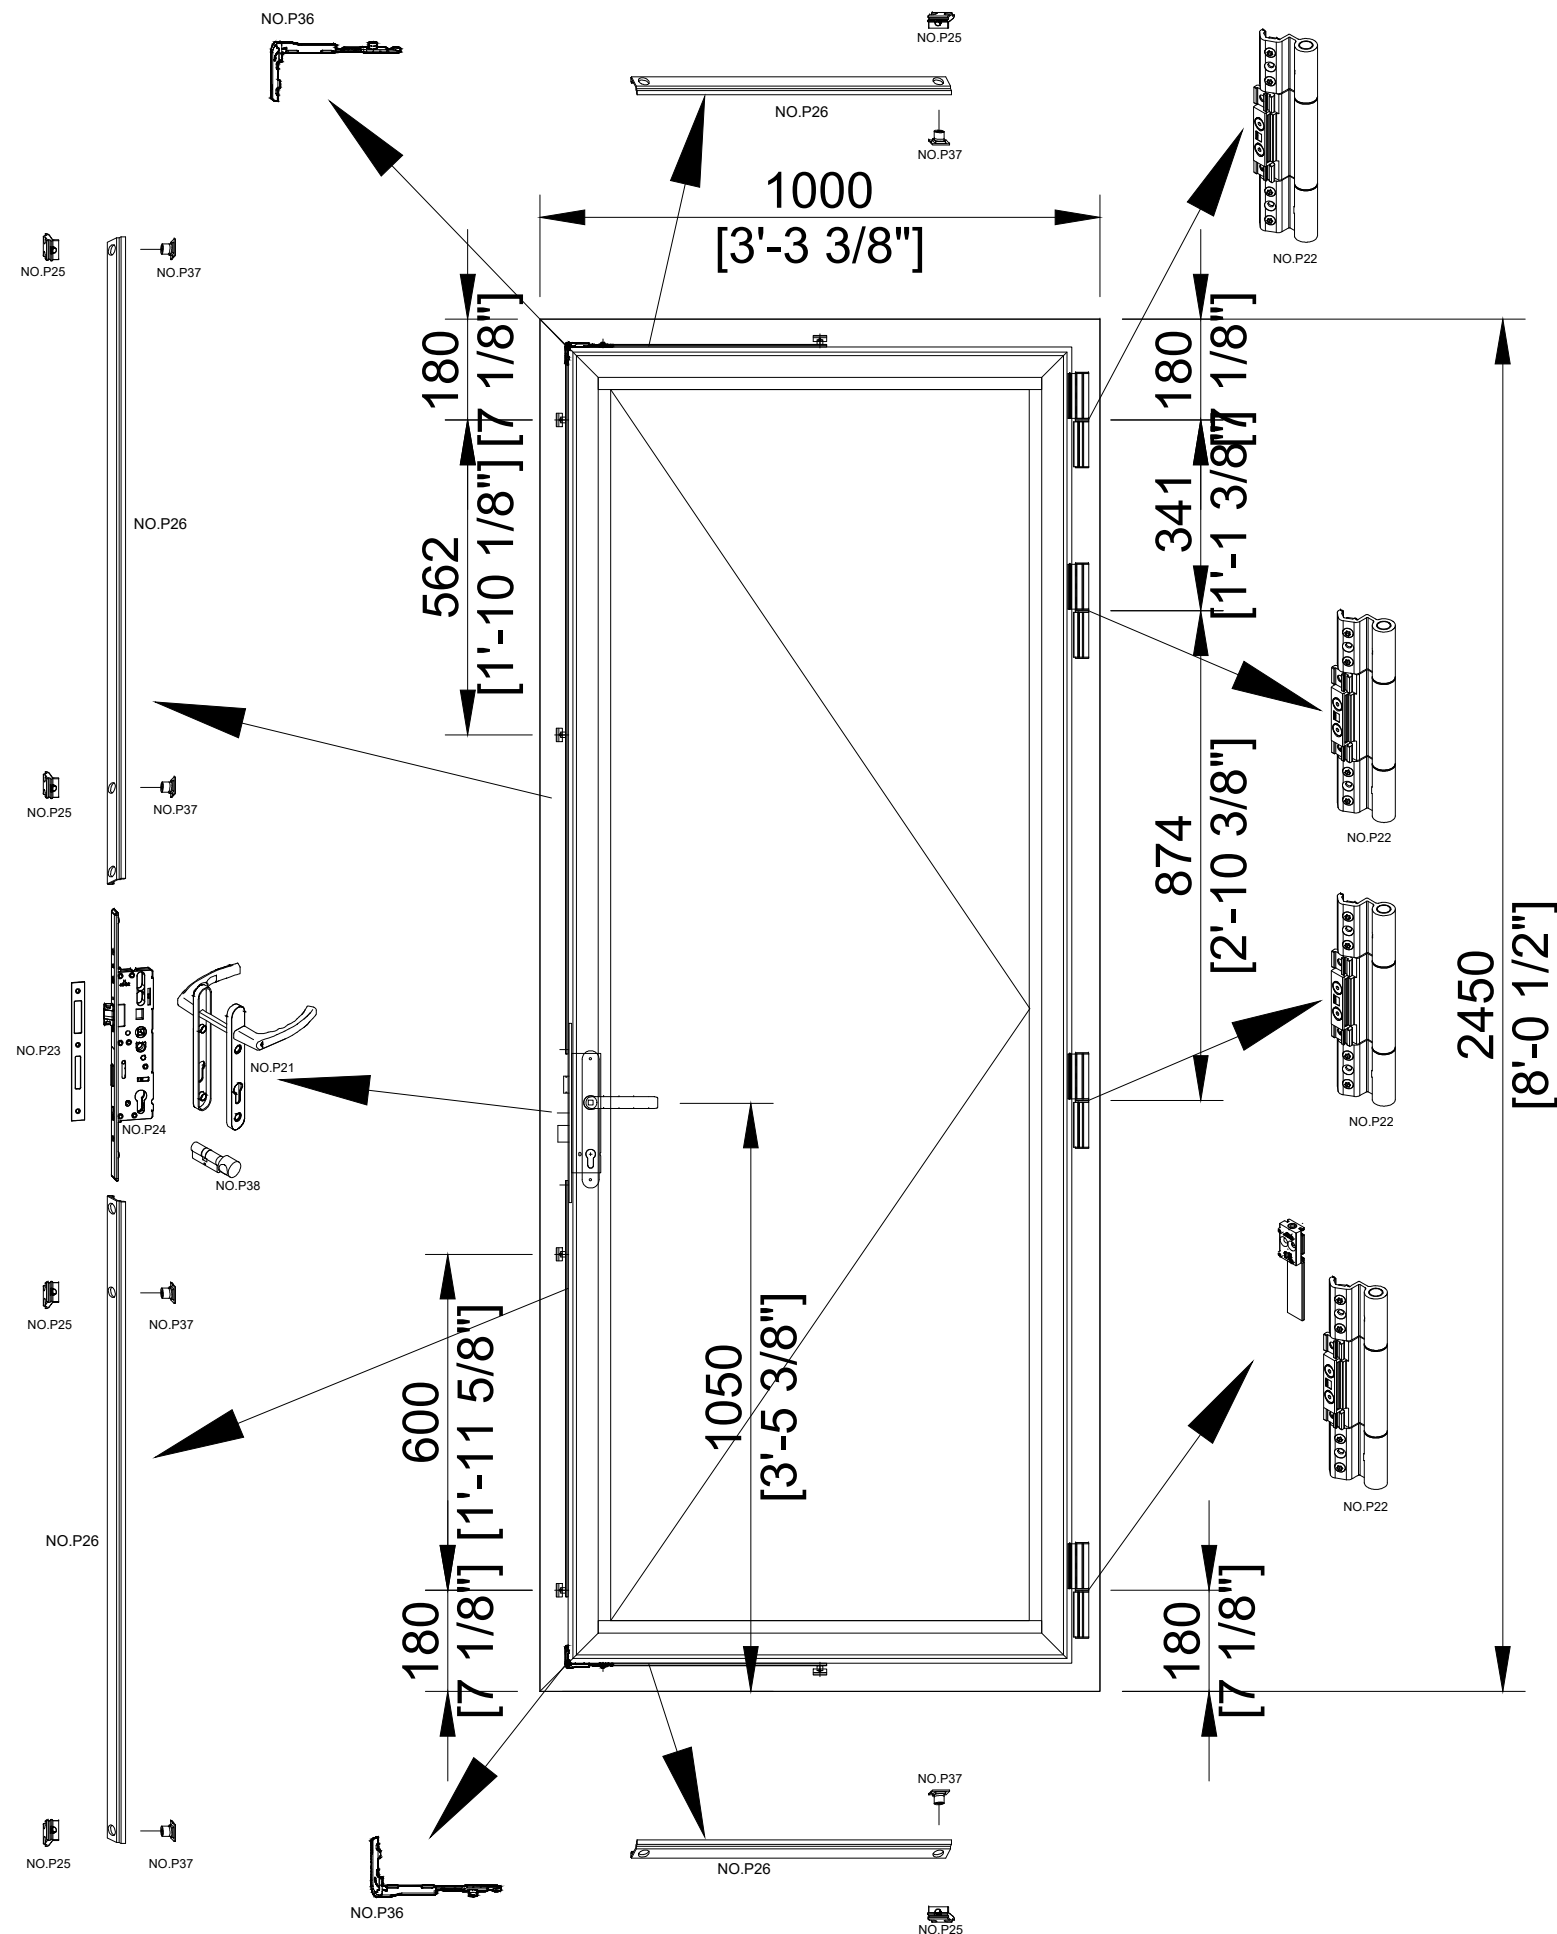
Hardware Distribution of Door

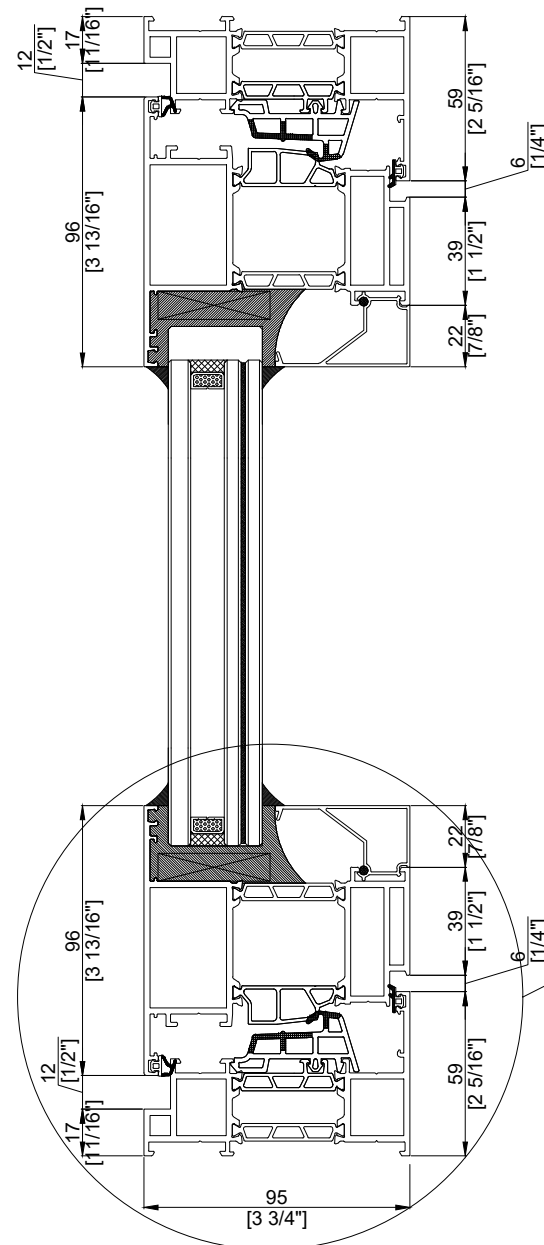
Longitudinal Section

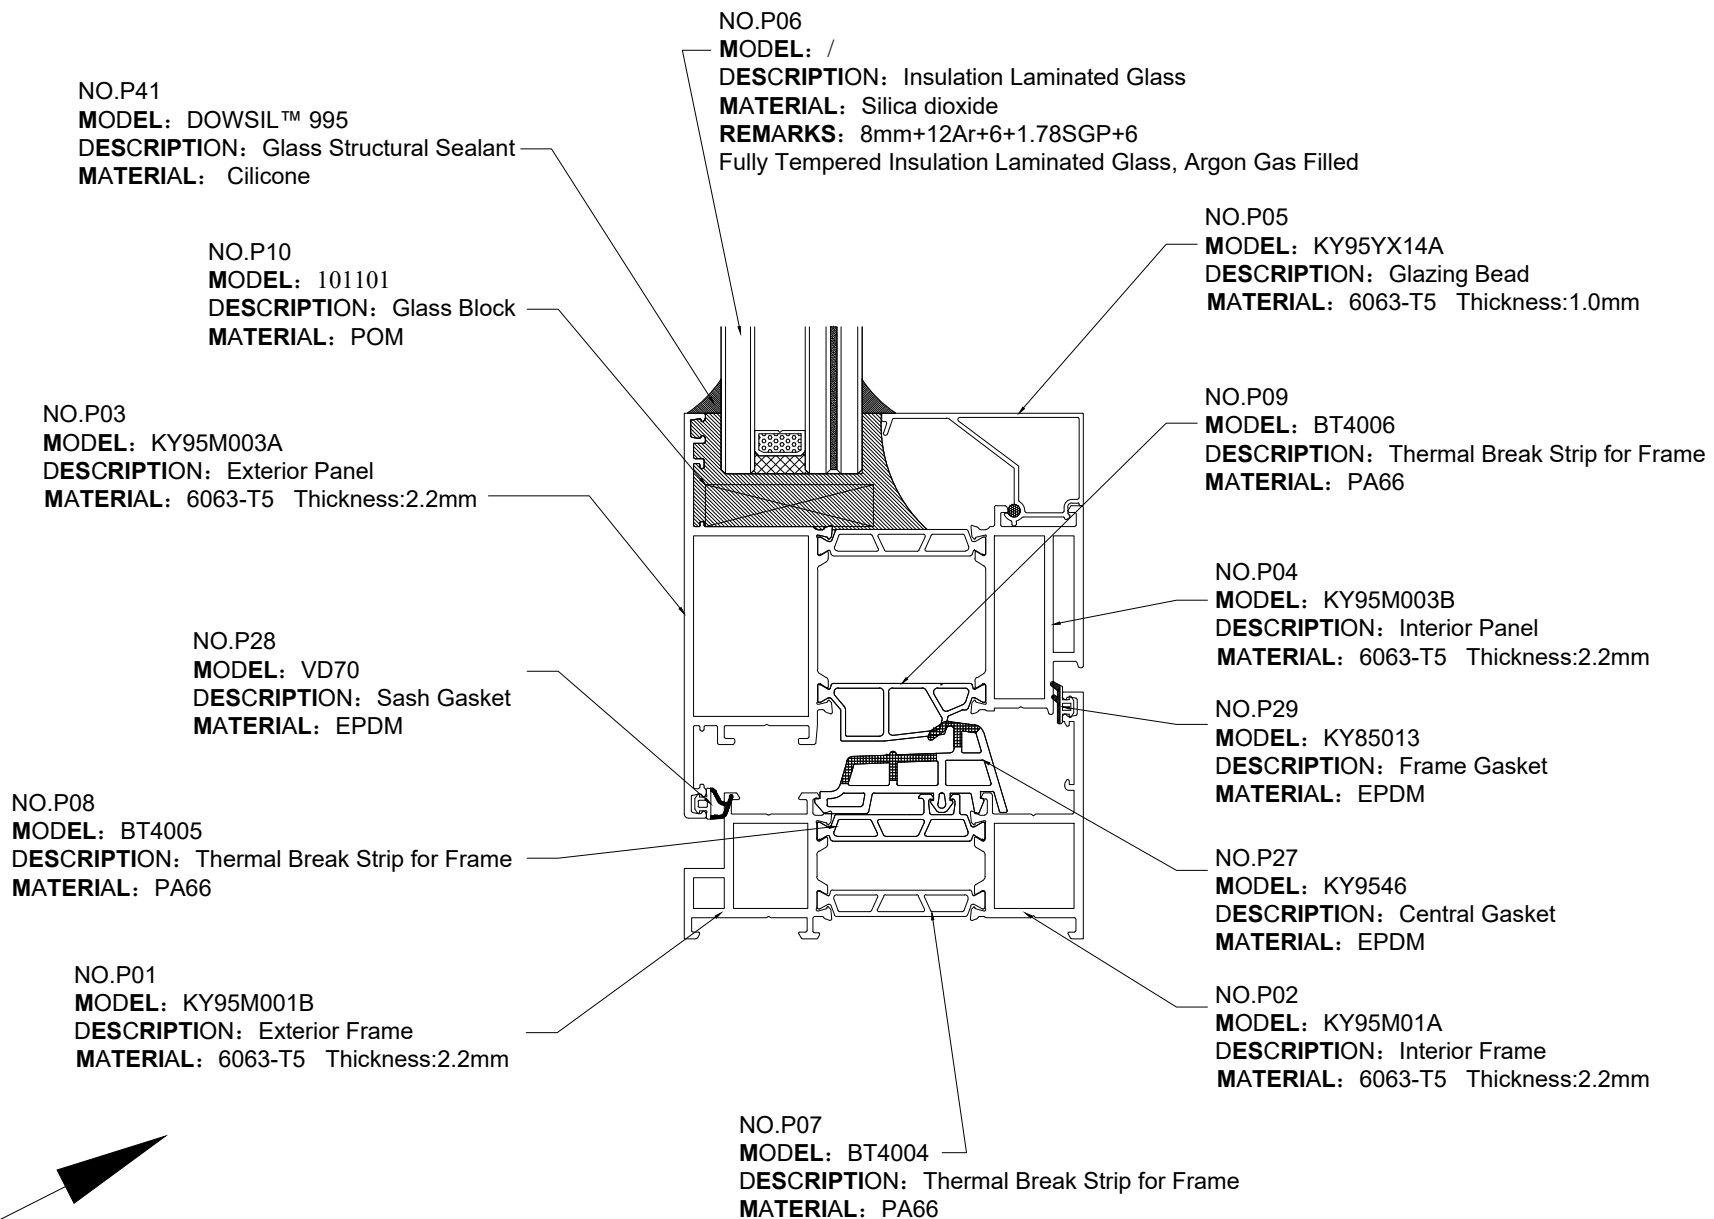
Cross Section

NO.P41  
MODEL: DOWSIL™ 995  
DESCRIPTION: Glass Structural Sealant  
MATERIAL: Cilicone

NO.P10  
MODEL: 101101  
DESCRIPTION: Glass Block  
MATERIAL: POM

NO.P03  
MODEL: KY95M003A  
DESCRIPTION: Exterior Panel  
MATERIAL: 6063-T5 Thickness:2.2mm

NO.P28  
MODEL: VD70  
DESCRIPTION: Sash Gasket  
MATERIAL: EPDM

NO.P08  
MODEL: BT4005  
DESCRIPTION: Thermal Break Strip for Frame  
MATERIAL: PA66

NO.P01  
MODEL: KY95M001B  
DESCRIPTION: Exterior Frame  
MATERIAL: 6063-T5 Thickness:2.2mm

NO.P06  
MODEL: /  
DESCRIPTION: Insulation Laminated Glass  
MATERIAL: Silica dioxide  
REMARKS: 8mm+12Ar+6+1.78SGP+6  
Fully Tempered Insulation Laminated Glass, Argon Gas Filled

NO.P02  
MODEL: KY95M01A  
DESCRIPTION: Interior Frame  
MATERIAL: 6063-T5 Thickness:2.2mm

NO.P07  
MODEL: BT4004  
DESCRIPTION: Thermal Break Strip for Frame  
MATERIAL: PA66
