PERFORMANCE TEST REPORT

GLASSCRAFT DOOR COMPANY

SERIES/MODEL: Buffalo Forge Steel Doors/Round Top Double
PRODUCT TYPE: In-swing Round Top Double Door LH-4-5/8

Report No.: 72618.01-801-44

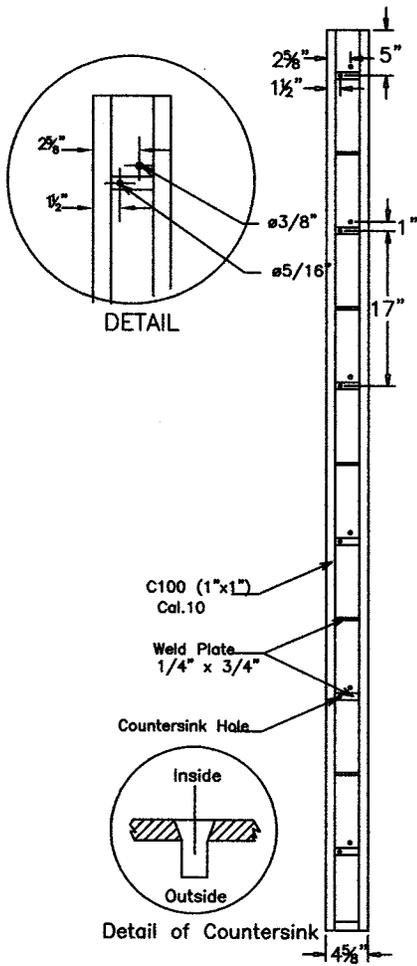
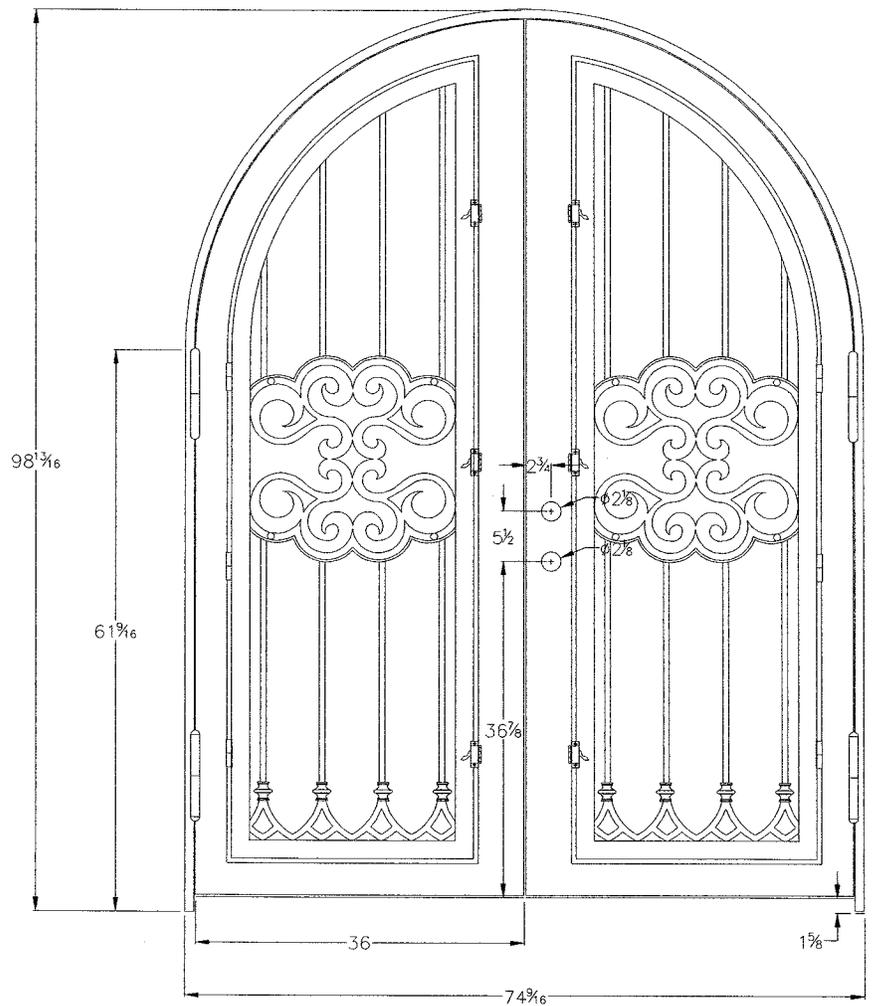
Double door
Full arch top

- 1. Door Hardware/ Schlege F-series handle set with Dead Bolt F358ply620
- 2. Z-series sill (Endura
- 3. 98" Compression w/strip bronze

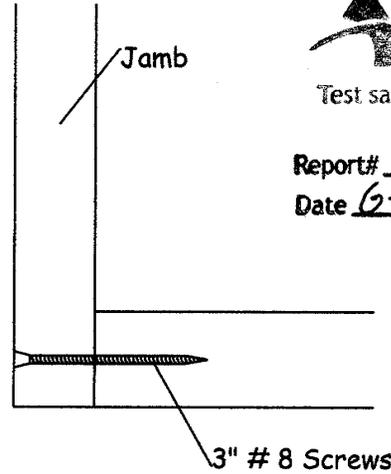
Front View

Threshold In Swing

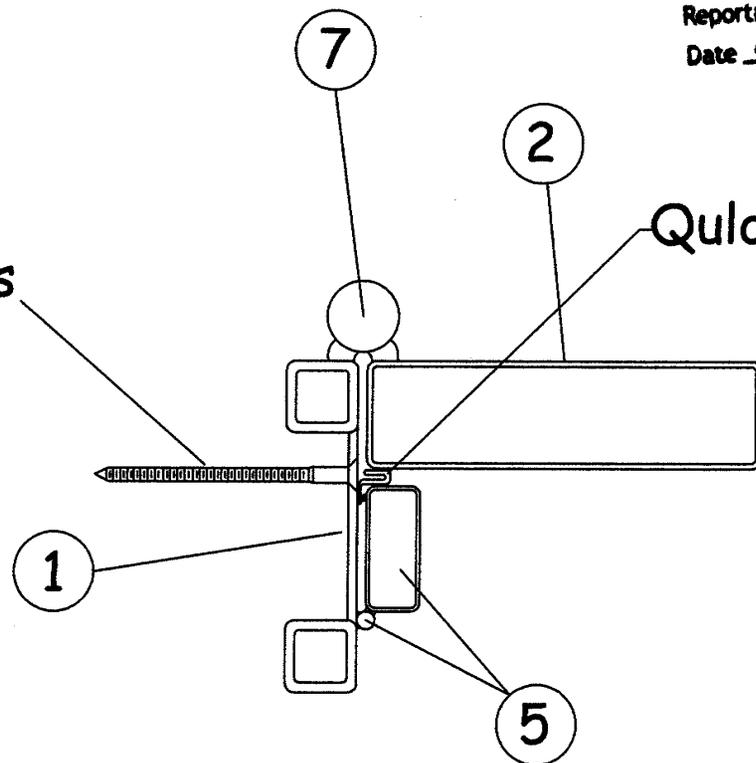
Door Jam Cross Section

3" # 14 F/H Screws

Qulon Weather Strip

- 1 Jamb
- 2 Stile
- 3 Glass
- 4 Forge
- 5 Door stop
- 6 Astragal
- 7 Prodeco hinge
- 8 Glass frame hinge
- 9 Forge frame
- 10 Fixed glass stop
- 11Screwed glass stop

Frame Construction: The door frame section was constructed of 4-5/8" thick steel jambs, and included an adjustable extruded aluminum threshold. The aluminum threshold was secured to the jambs with three #8 x 3" screws at each end.

Installation: The jambs were secured to a #2 Yellow Pine test buck with #14 x 3" screws 9" from each corner and 16" on center thereafter.

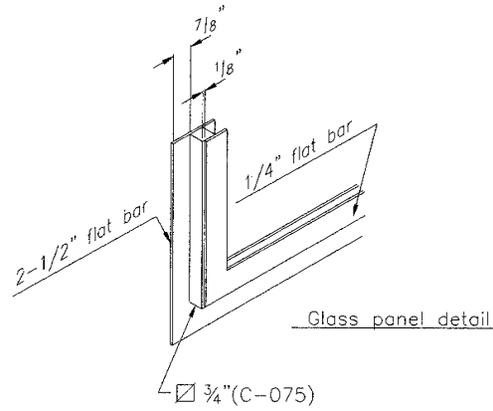
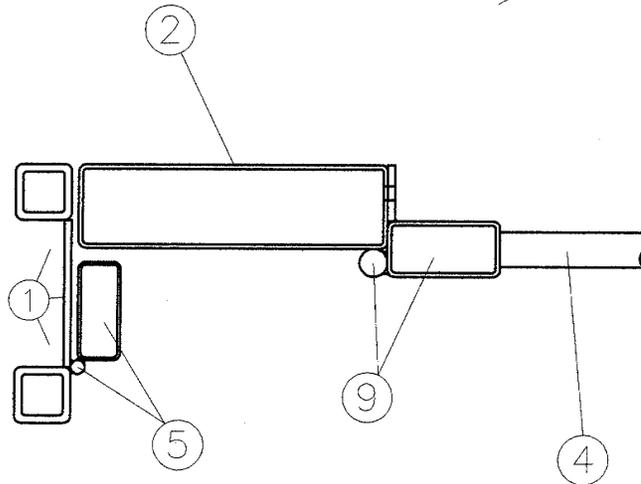
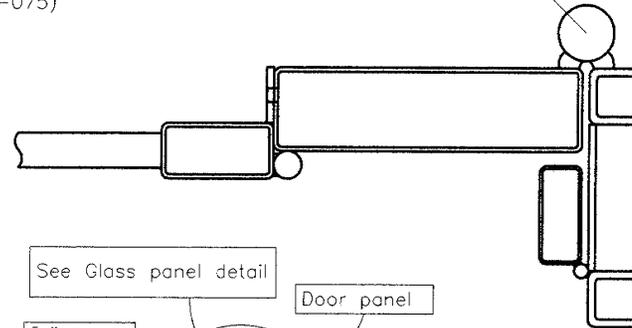
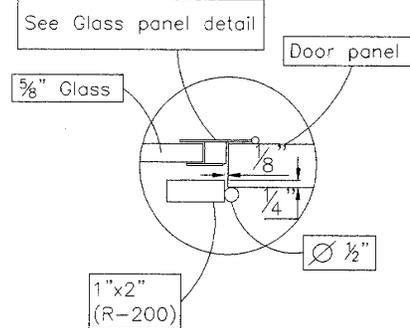
Single door Cross Section

- 1 Jamb
- 2 Stile
- 3 Glass
- 4 Forge
- 5 Door stop
- 6 Astragal
- 7 Prodeco hinge
- 8 Glass frame hinge
- 9 Forge frame
- 10 Fixed glass stop
- 11 Screwed glass stop

Leaf Construction: The door leaf was constructed from steel with a foam core. A glass frame was secured to the door leaf with three barrel hinges and three sweep latches. Sweep latch keepers were welded to the door leaf. A decorative iron grille was secured at the exterior of the unit.

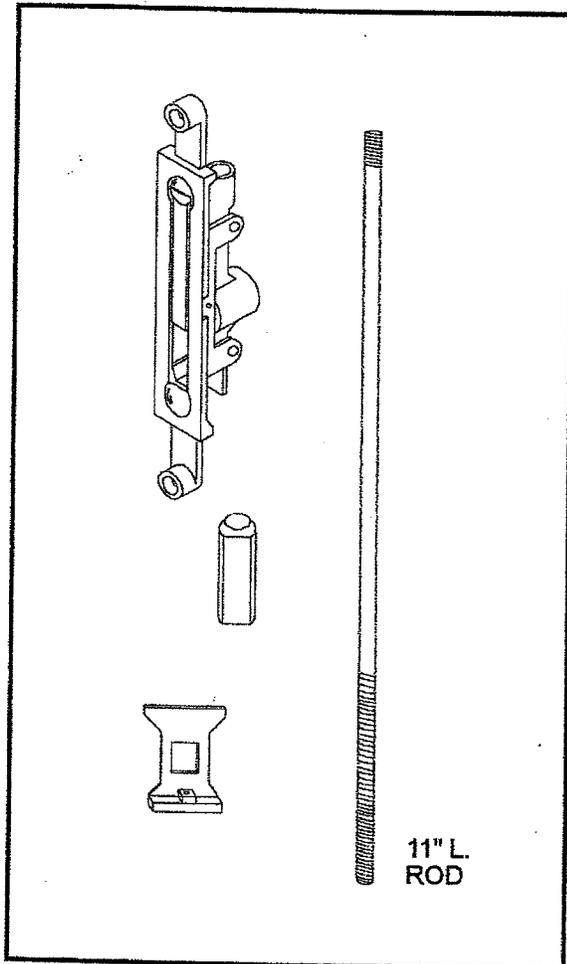
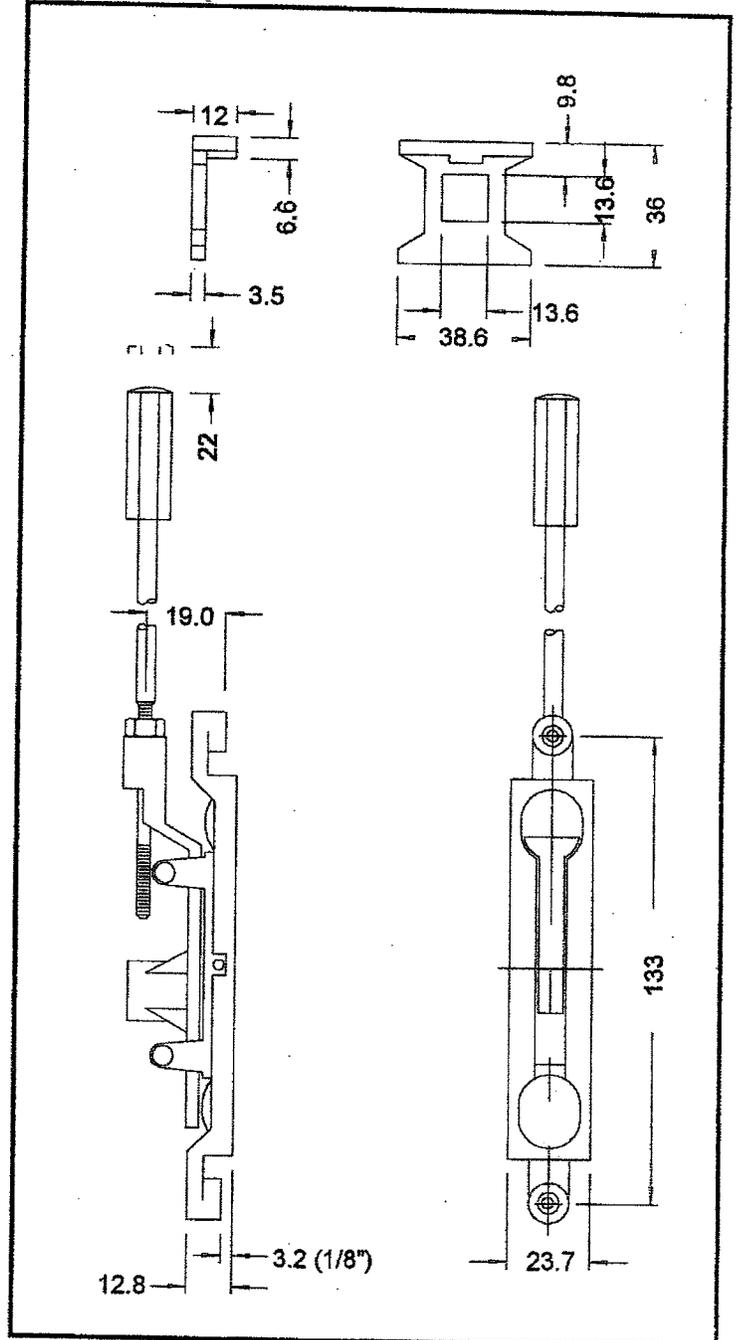
Z/C FLUSH BOLT

Product code: FB1
Zinc alloy flush bolt with
11" rod.

- *Positive "U" joint actuator with 7/8" throw
- *1/8" offset with 3/4" backset.
- *5/8" adjustment on rod length.
- *Round brass tip
- *Finish option:
AL: Baked satin aluminum.
DU: Baked duronodic.
BK: Baked black.
