Residential Roofing And Hurricanes

**June 2005
Version 1.0**

**Florida Building Commission
2555 Shumard Oak Boulevard
Tallahassee, Florida 32399-2100
(850) 487-1824**

Residential Roofing and Hurricanes

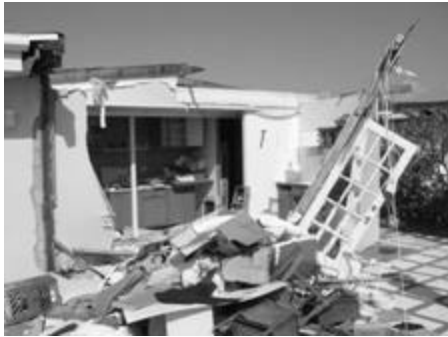
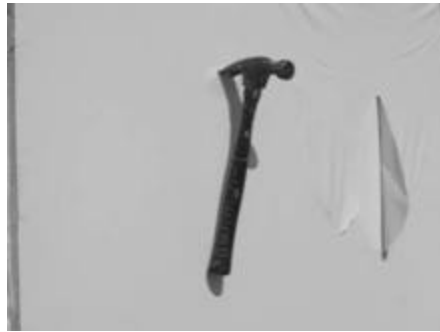
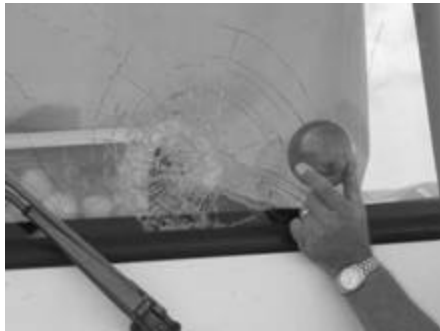
Flying debris and downbursts...

Significant structural damage made roof analysis difficult at best.

As can be imagined, it is sometimes hard to determine exact causes of damage. For example, downbursts and flying debris like this hammer in side of house--that did not belong to owner of home--and this ornamental glass ball that caused window damage to front windshield of motor home.

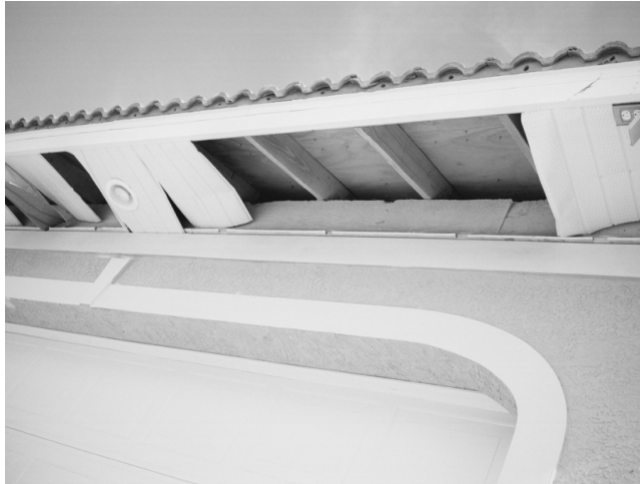
17

For instance, the roof on this structure would have been evaluated but...

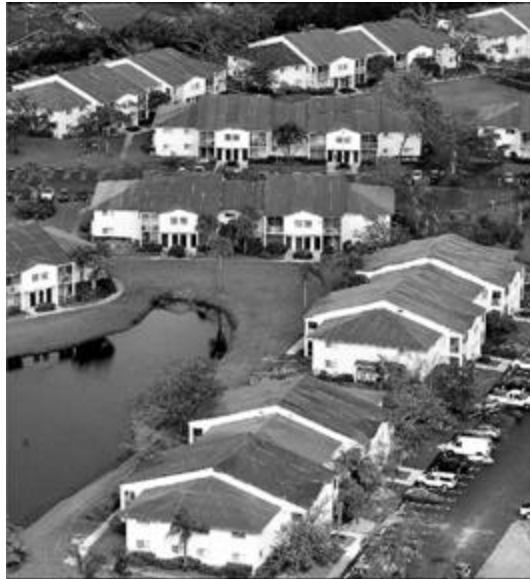
23

The 2004 hurricane season was memorable for a number of reasons. Probably, few will soon forget the Blue Roof Syndrome where, in some cases, entire apartment complexes or developments had their roofs tarped in blue due to roof damage. In this case it is an apartment complex in West Palm Beach (October 2004).

[Notice the lack of overhang at gables.]

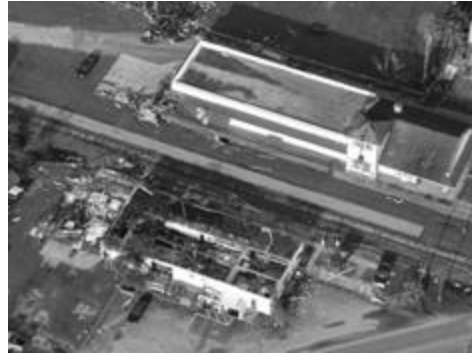
36

Aerial shots of flat roofs
in Port Charlotte

Internal pressurizations of
structures, often times
commencing at soffit /
overhangs of buildings

An example of damage to flat roofs

Many flat and low-slope roof systems show damage primarily at roof corners.

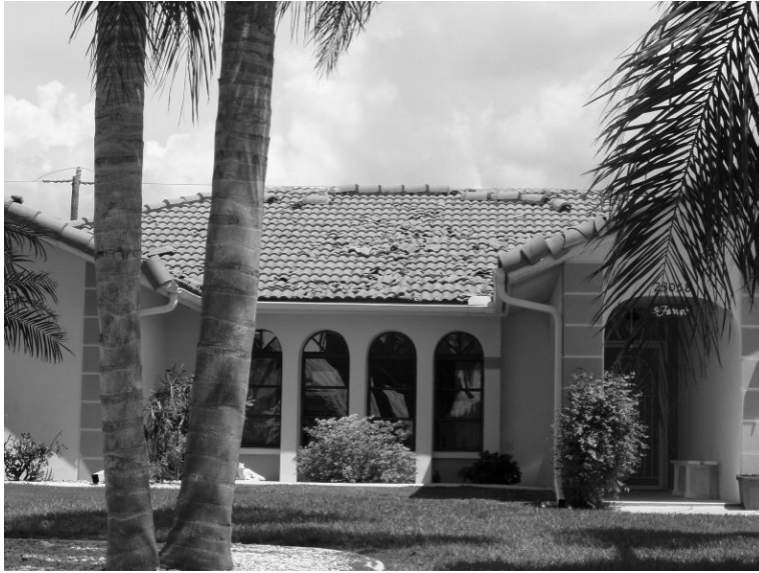
38

Different roof coverings also suffered damage...including concrete tile...

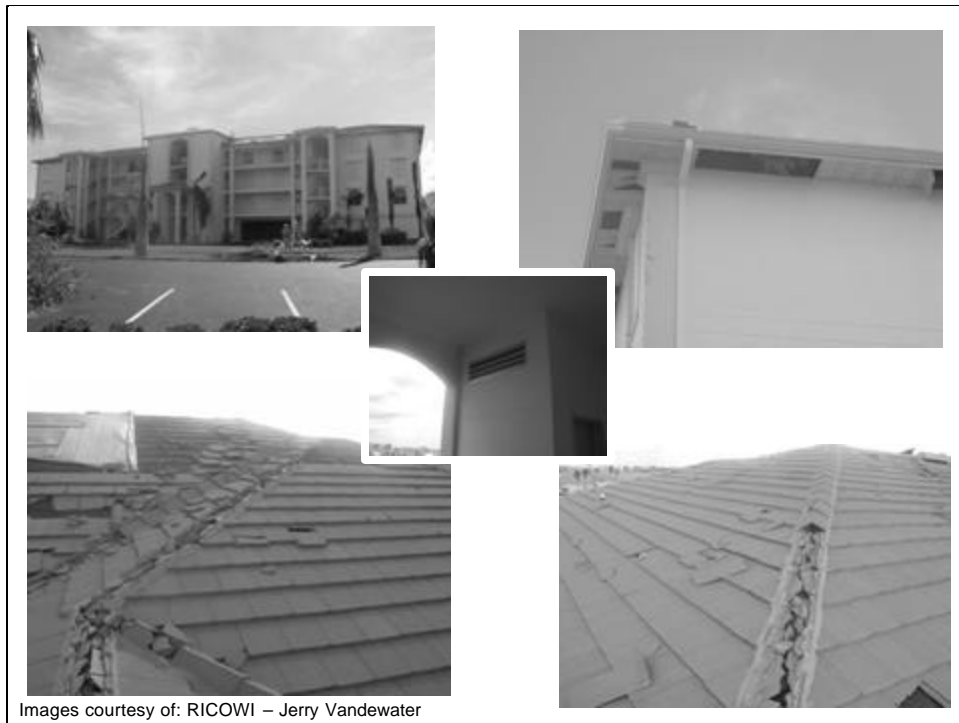
**Concrete tile—mechanical attachment**

- Pressurization of the building—soffits blown out
- Entire roof "survived" except hips and ridges
- Set trim tiles only in mortar
- Field tiles might have "survived" but tiles damaged

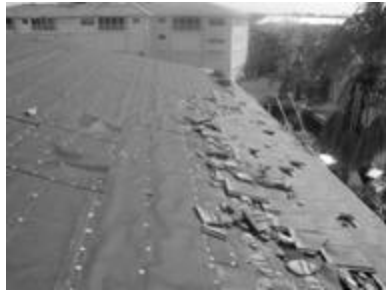
44

Tiles on this project created damage on lower parking area. Unable to determine if the damage was caused by the storm or from the clean-up.

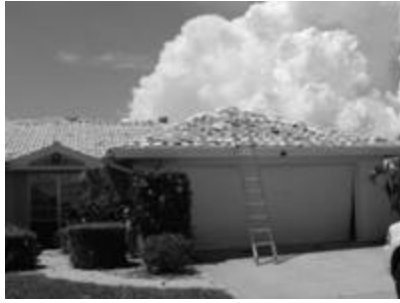
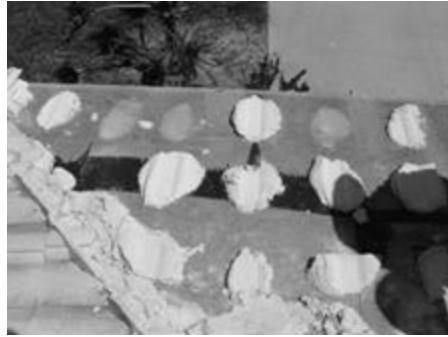
Concrete tile—mortar attachment

Mortar in wrong location; wind got underneath, resulting in photo on lower left.

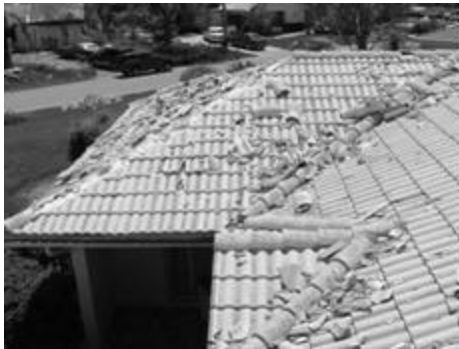
Problems with bond of tile
to mortar and mortar to
underlayment

Problems with mortar
at hips and ridges

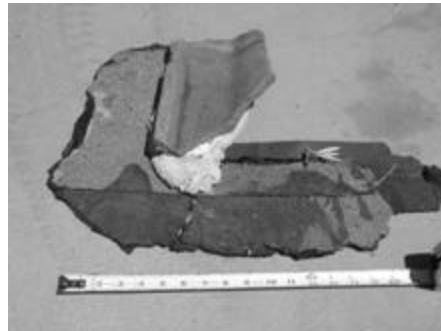
Mortar manufacturer's
instructions call for
#10 trowel of mortar

Age of underlayment
may come into play

Underlayment to deck—
bonding issue

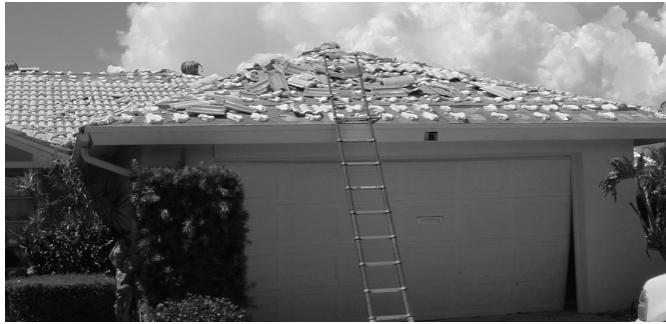
47

There are specific requirements for type of mortar and placement.

Mortar installation
in Punta Gorda

- Windward face of roof
- Notice hip and ridge

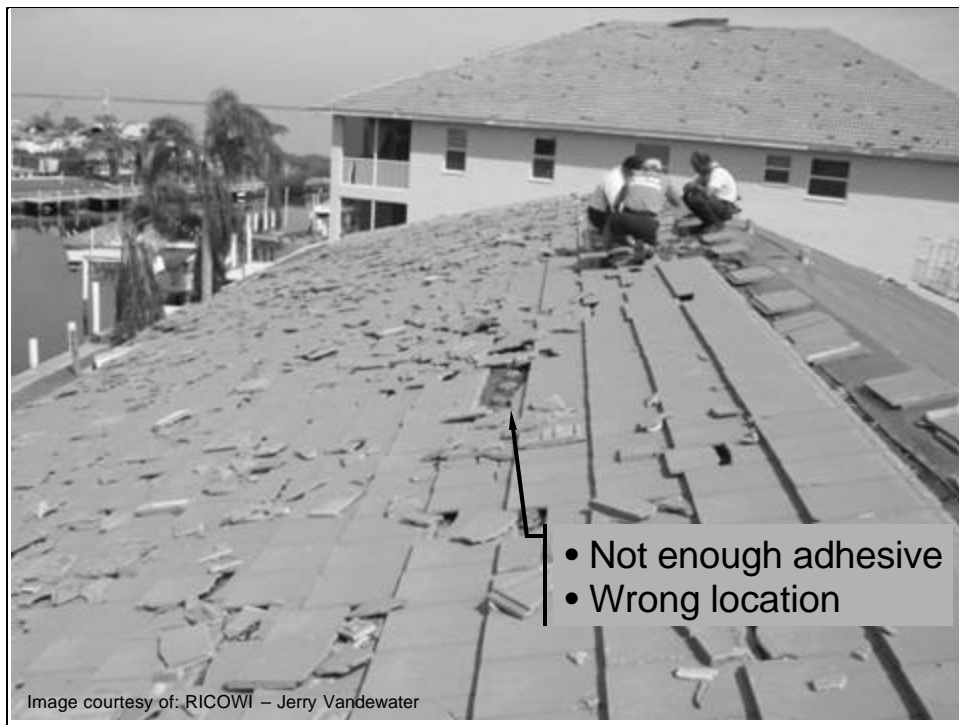
Concrete tile—adhesive set systems

Location of adhesive very important.

A lot of impact damage in this case.

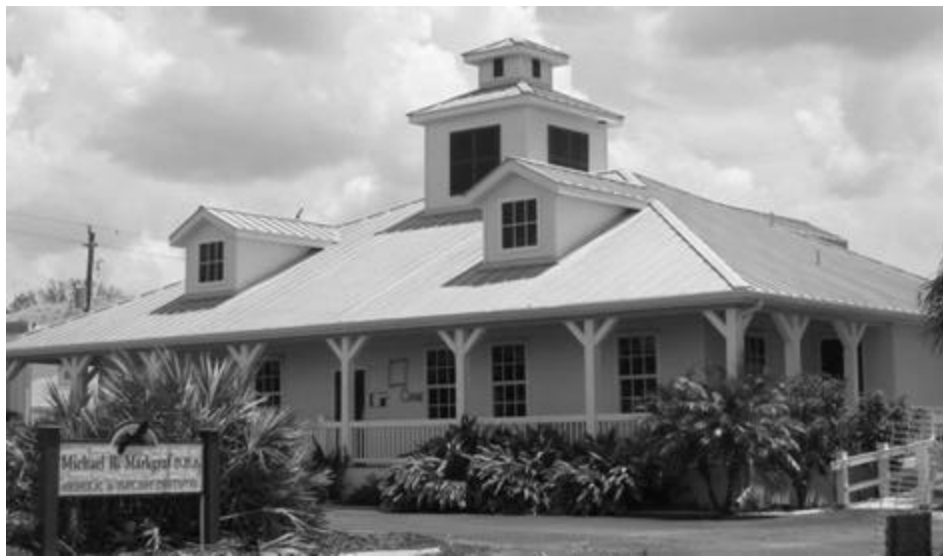
5 V-ribbed metal that did well...a lot of fasteners in this system

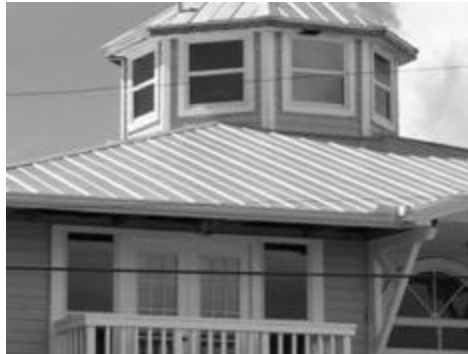
More thru-fastened steel

Attached to plywood—screws 6 in. o.c.

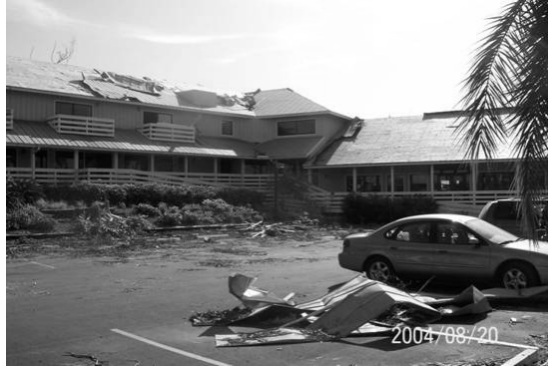
Thru-fastened 5V crimp

Panels were adequately fastened to 1 x 4 stringers, but the stringers were attached to the plywood with only 6d nails, 12 in. o.c.

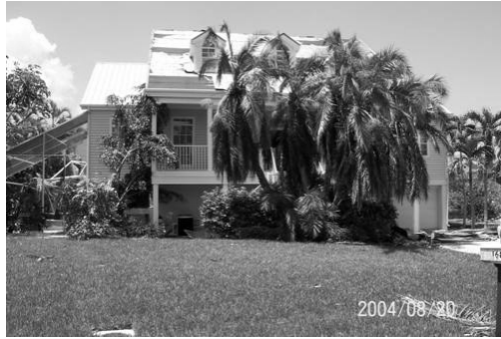
Thru-fastened 5V crimp

- Panels fastened to 1 x 4 stringers
- The stringers were attached to the plywood with 4d nails, 24 in. o.c.

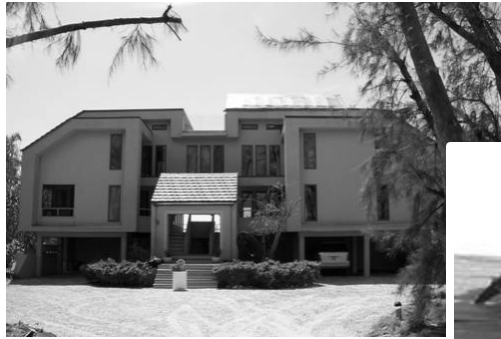
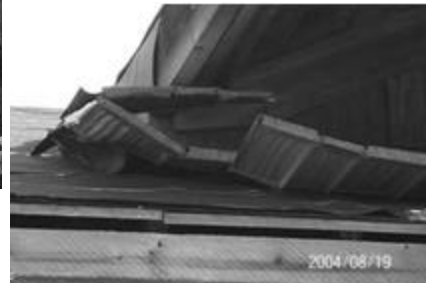
Aluminum shingles which unlocked,
then pulled off, or tore from, nails.

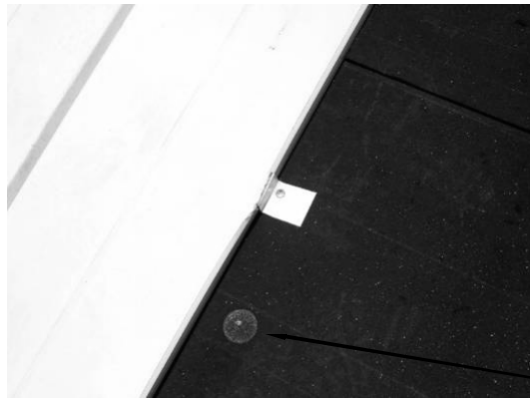
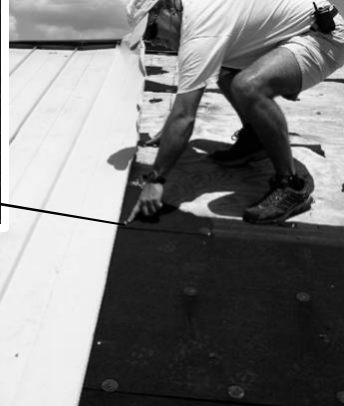
Clips were torn off deck

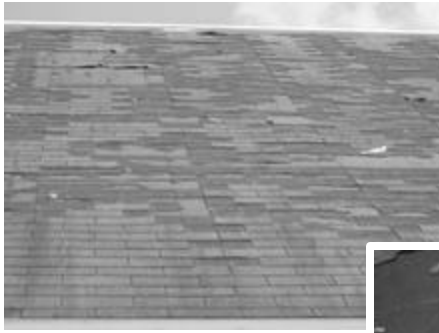
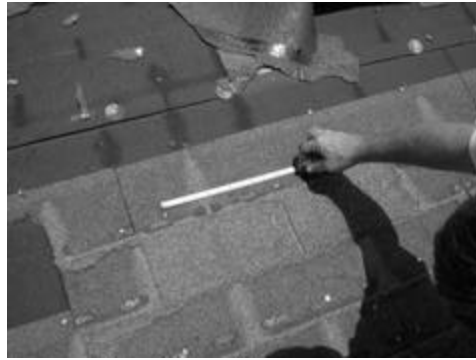
Captiva

- Lack of proper fasteners

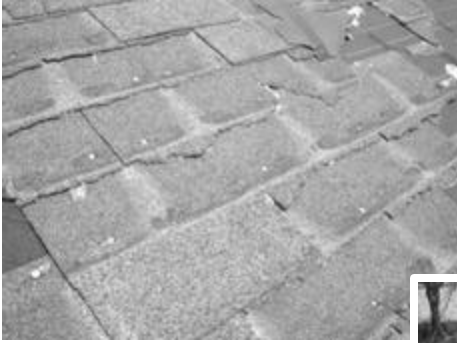
East Harbor Heights

Wind blew off roofing and decking, and sucked out insulation from attic.

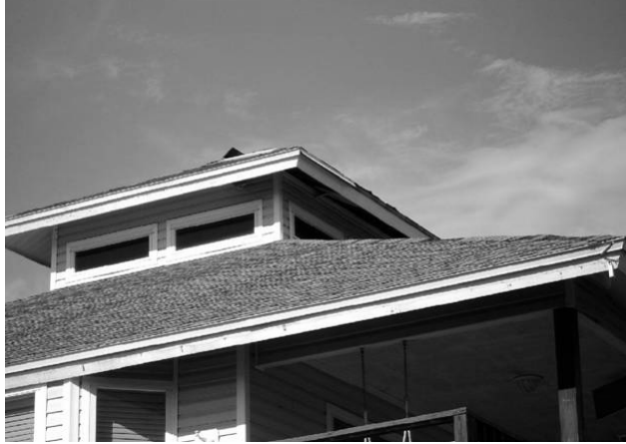
Composite shingle roof—some hip/ridge loss. Nailed with 6 nails per shingle.

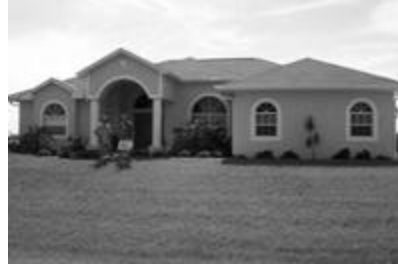
Some ridge pieces tore from nails.

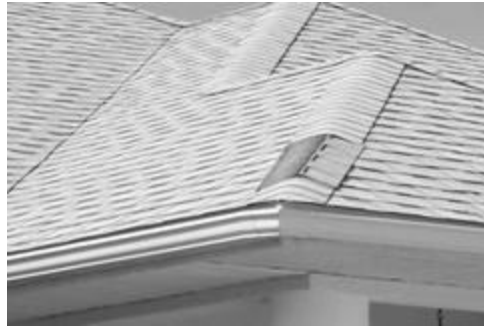
Field loss—6 nails placed in seal strip

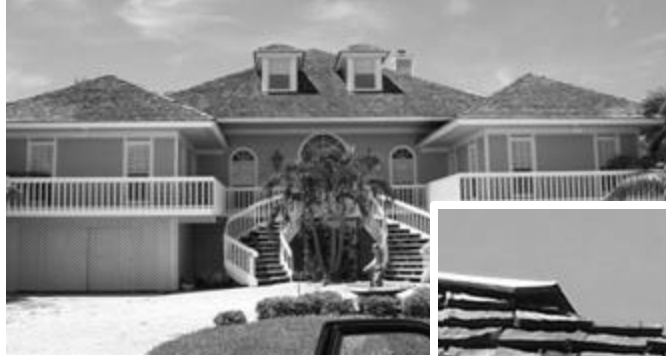
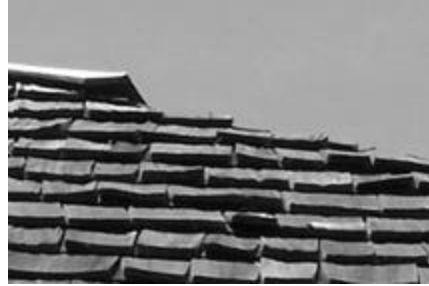
7- to 8-year-old wood shake roof.
Over-exposure (14 in.) on hip loss.

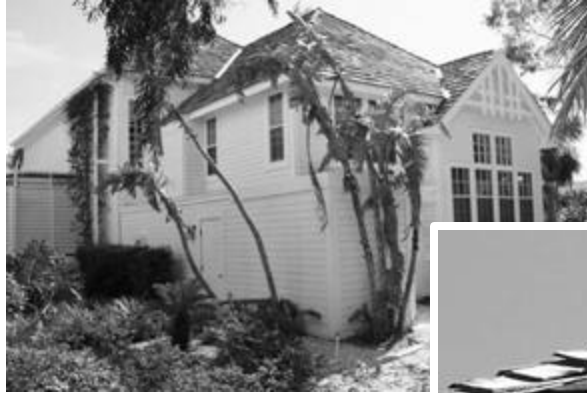
- Heavy shake
- Large overlap

Some wood hip/ridge pieces lost

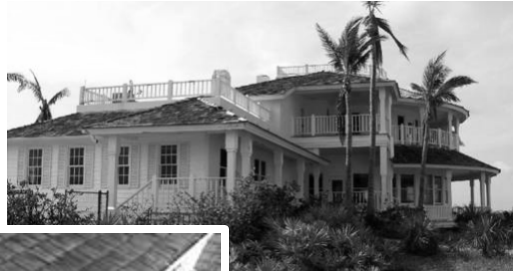
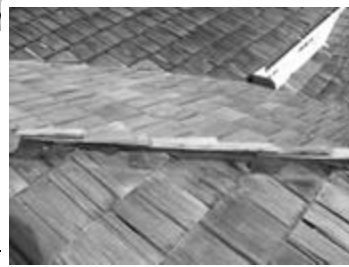
Nailed wood shakes with little field loss,
but stapled hips fared worse.

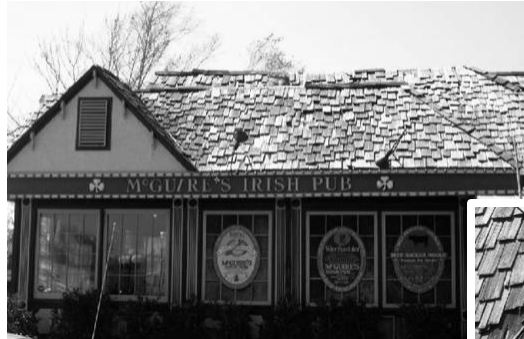
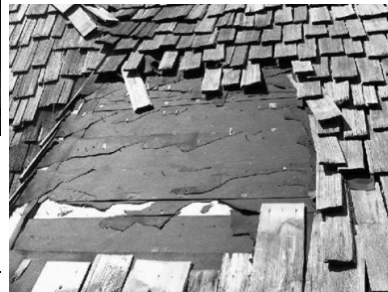
Wood shake loss from nailing 20 in. from butt
